## Research Article

## A Novel Method to Perform the Burst Pressure Test on the Repaired Drinking Water Pipelines

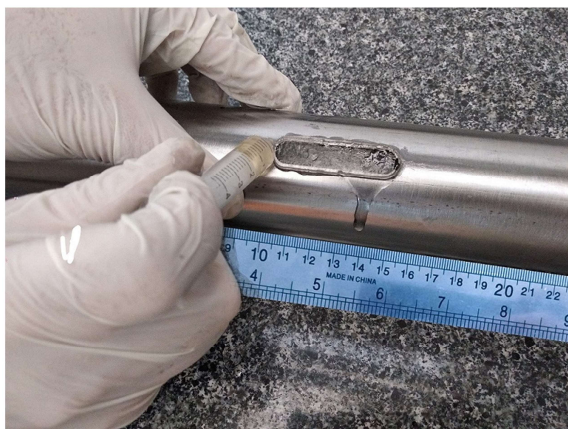
Fig. 2. Inserting a molded resin into the specimen defect, using the similar liquid resin as the adhesive.

machining a steel block, and the liquid resin was then poured into the molds, which were in the form of artificial defects of the pipe. The molded resin pieces were produced after curing the resin at room temperature. Next, according to Fig. 2, the molded resin was manually inserted into the specimen defect, and a similar liquid resin was used as adhesive to bond the lateral surfaces of the molded resin to the inner surfaces of the defect. After curing the adhesive, the repaired pipe by the polyester resin is prepared.

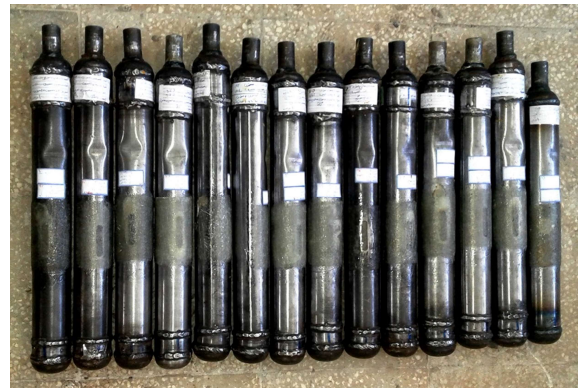
Fig. 5. Some of the specimens after the test.

As a primary stage of each test, the initial pressure of the connected specimens to the circuit reached 10 bar by the hydraulic pump with manual excitation. Then, the ball valve between the pump and the circuit was closed, and the pump was disconnected from the circuit and the specimen. In the following, the connected specimen to the circuit (without pump) was placed inside a universal testing machine, between a rigid flat plate and a rigid cylindrical punch, such that the cylindrical punch was far away from the repaired location of the pipe. Later on, the universal testing machine began and the rigid cylindrical punch moved with a constant displacement rate of 2 mm/min, so the punch applied the compressive force on the repaired pipe and due to lateral crushing and reduction of the internal volume of the pipe, the internal pressure of the pipe increased, gradually; without any plastic deformations in the repaired zone of the pipe. This test continued until the first leakage was observed at the repaired location of the pipe. A DMG universal testing machine, Model 7166, was used to perform the burst pressure test. Fig. 4 illustrates a specimen in the DMG universal testing machine during the burst pressure test. Fig. 5 shows some of the specimens after the test.

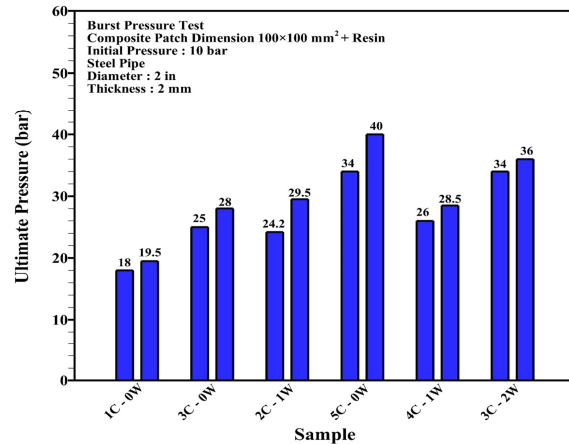
Fig. 7. Rupture pressure of the repaired specimens by the molded resin and a composite patch with dimensions of  $100 \times 100 \text{ mm}^2$ .

Fig. 7 shows the maximum pressure of the 2-inch steel specimens repaired by the molded resin and composite patch with dimensions of  $100 \times 100 \text{ mm}^2$ . The reported results in the figure demonstrate that repairing the steel pipes using a single layer chopped strand mat can sustain the internal pressures up to 19.5 bar, and if the number of layers of the glass fiber chopped strand mat

is selected up to 3 or 5, the repaired pipes can sustain the internal pressures up to 28 and 40 bar, respectively. On the other hand, in the studied domain, by increasing the number of chopped strand mats, the maximum sustainable pressure by the repaired pipes increases, as well. Additionally, a comparison between the experimental results of the repaired specimens by 3-layers laminate with two different configurations of 3 chopped layers- zero woven layer, and 2 chopped layers- 1 woven layer illustrates that replacing a layer of chopped fibers with a layer of woven fibers, does not change the internal pressure capacity of the pipes, considerably. Therefore, due to the economic considerations, using chopped fibers is recommended for the mentioned application. In the repair process by the molded polyester resin and 5-layers laminates, the rupture (maximum) pressure of the repaired specimens by 5-layers of chopped fibers is in the range of 34-40 bar, the rupture pressure of the repaired specimens with 4 chopped layers- 1 woven layer is in the range of 26-28.5 bar and the rupture pressure of the repaired pipes by 3 chopped layers- 2 woven layers were determined in the range of 34-36 bars. Hence, similar to the 3-layers laminates, in the repair process of the drinking water pipes by the 5-layers composite laminates, using the chopped fibers rather than the woven fibers are recommended. In sum, in the repair process of the steel pipes with the  $100 \times 100 \text{ mm}^2$  composite patch, the

However, comparing the reported results in Fig. 7 and Fig. 8 demonstrates that in some cases, the increment of layer numbers or composite patch dimensions does not enhance the maximum internal pressure of the repaired pipes. It may be due to a longer required time for performing the hand layup process of a larger composite patch on the pipe wall; and so, sooner curing the resin during the mentioned time and consequently, reduction of the quality of the produced composite patch, which may be eliminated by increasing the number of workers who perform the hand layup repair process. It is important to note that according to the instructions of the employer of this research project, the purpose of this study is to provide a completely practical method for repairing the drinking water transmission lines in out-of-town areas without using electrical or advanced equipment; therefore, in the repair process of the laboratory specimens, the mentioned trend was considered.

In Fig. 9 and Fig. 7, the comparison of the corresponding results with the same layer numbers and layer configurations of the composite patch and with the different molded parts of putty and resin demonstrates that in most configurations, the rupture pressure of the repaired specimens by using the putty is higher than the corresponding repaired specimen by using the molded resin. As numeric investigations indicate, the results demonstrate that in the repaired specimens by the composite patch of 3 chopped layers- zero woven layer, the maximum rupture pressure of the repaired specimen containing the molded putty is 57% higher than the maximum rupture pressure of the corresponding specimen containing the molded resin. In the repaired specimens by the composite patch of 5 chopped layers- zero woven layer, the maximum rupture pressure of the repaired specimen containing the molded putty is 1.4 times the corresponding value of the corresponding specimen containing the molded resin.

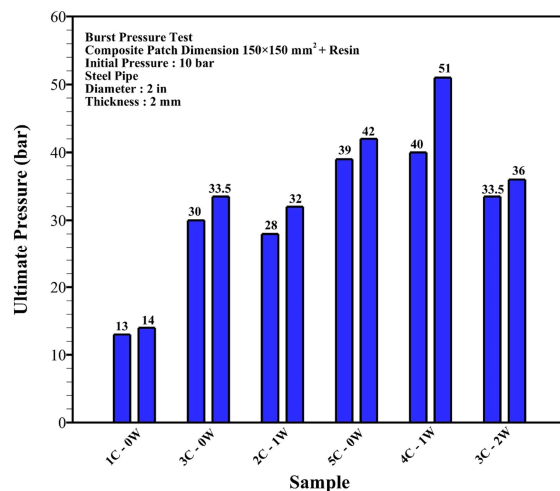
Fig. 8. Rupture pressure of the repaired specimens by the molded resin and a composite patch with dimensions of  $150 \times 150 \text{ mm}^2$ .

Fig. 8 illustrates the maximum pressure of the repaired steel specimens by the molded resin and composite patch with the dimensions of  $150 \times 150 \text{ mm}^2$ . The results show that the pipes repaired with a single-layer of the chopped fibers can withstand the internal pressure up to 14 bar, and by increasing the layer numbers of the chopped fibers to 3 or 5, the maximum internal pressure of the repaired specimens reaches higher than 20 bar, which is desirable for this application. Moreover, a comparison of the results of the performed tests on two types of repaired samples with 3-layers laminate shows that the maximum internal pressures of two specimens with 3 chopped layers- zero woven fiber, and 2 chopped layers- 1 woven fiber are, approximately, the same. Hence, similar to the previous discussion and based on the economic considerations, using the chopped fibers is recommended. In addition, in different repair types with 5-layer laminate, including 5

chopped layers- zero woven layer, 4 chopped layers- 1 woven layer, and 3 chopped layers- 2 woven layers, the rupture pressures were measured in the range of 22-51 bar. Therefore, repairing the 2-inch steel pipes by the composite patch of  $150 \times 150 \text{ mm}^2$  dimension is a suitable method to achieve sustainable pressure capacities of higher than 20 bar, depending on the layer number of the composite patch and skill of the person who performs the hand layup repair process.

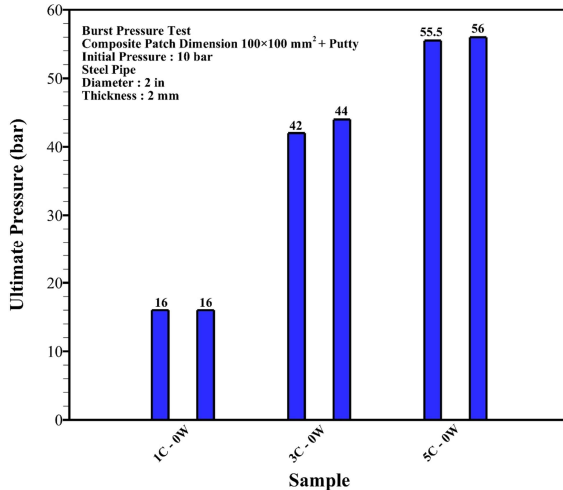
**Fig. 9.** Rupture pressure of the repaired specimens by the molded putty and a composite patch with dimensions of  $100 \times 100 \text{ mm}^2$ .

Fig. 9 shows the maximum internal pressure of 2-inch steel specimens, repaired by the molded putty and a composite patch of  $100 \times 100 \text{ mm}^2$  dimension. In the preparation process of the polyester putty, resin and talcum powder were used, based on a certain weight ratio of 70-30. The specimens of this group were prepared in 3 different types, including 1, 3, and 5 chopped layers and without any woven layers. The reported results in the recent figure show that the repaired steel pipes by the molded putty and a composite patch of a single chopped layer can sustain the internal pressures up to 16 bar, and when the layer number of the composite patch is selected equal to 3 or 5, the repaired pipes withstand the internal pressure of up to 44 and 56 bar, respectively.
